## VERTICAL ROOT FRACTURE DIAGNOSIS IN ENDODONTICALLY TREATED TEETH

Gadzhula N. G., Fedyk T. V., Goray M. A., Yasko V. V.

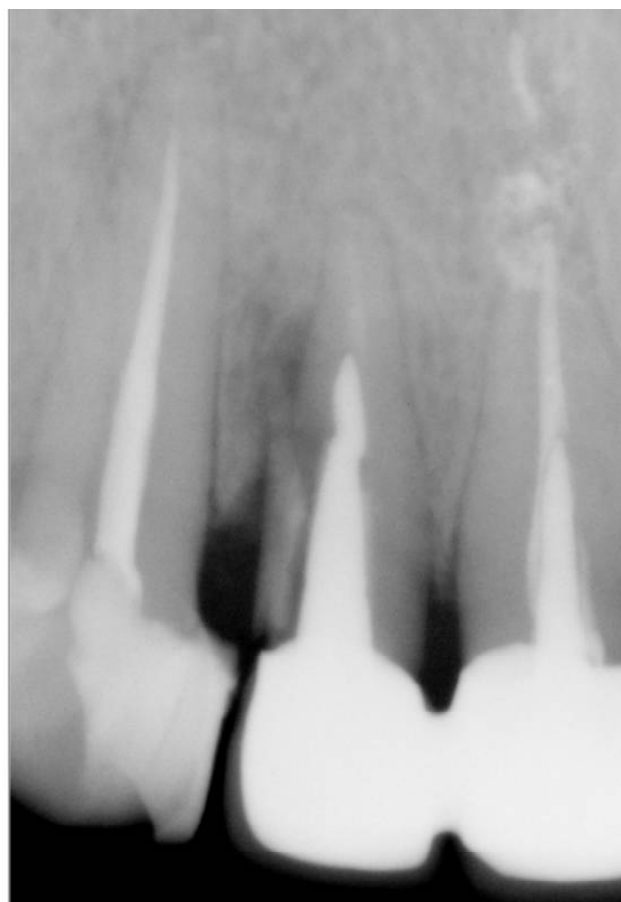
Fig. 1. Oblique root fracture of 1.2 tooth with displacement.

Radiological results. Only in 6 clinical cases (17.6±6.53%) on the intraoral radiograph a vertical fracture line was revealed (Fig. 1). In 4 cases (12.5±5.67%) no pathological changes of bone tissue in the tooth area with a vertical root fracture were observed, but in two of them the radiograph diagnosed a shadow oriented parallel to the filling material and atypical exit of the sealer to the lateral root surface. Such changes, according to most authors [5, 7, 8, 10] occur in vertical root fracture, which appeared directly during root canal obturation.

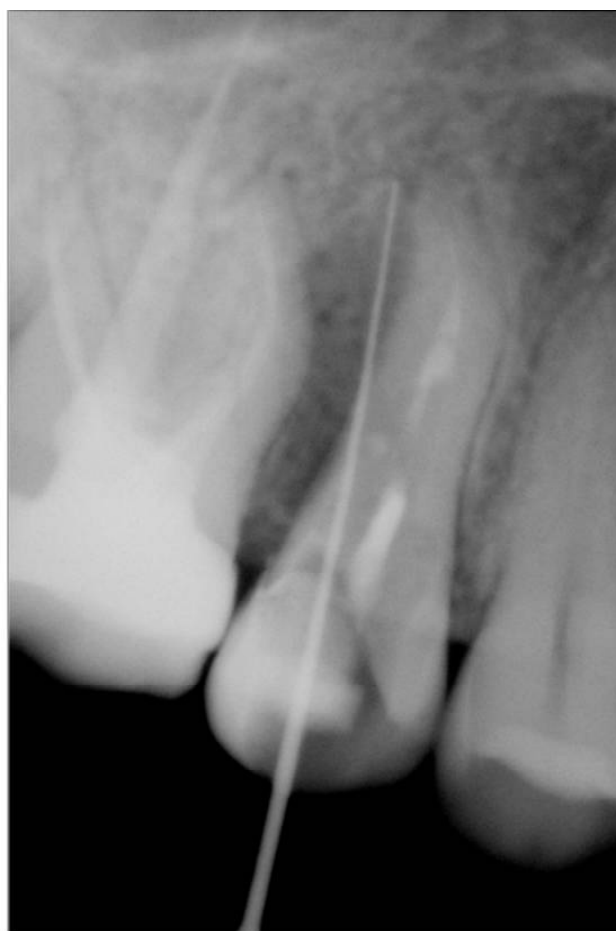
Fig. 2. J-shaped or halo-type of bone destruction in periapical zone and along the lateral root surface of 1.5 fractured tooth (oblique fracture).

Bone resorption were revealed in 30 clinical cases (88.2±5.53%): most often in 24 clinical cases (80.0±6.16%) a J-shaped area of destruction (halo-type) was observed in the periapical bone and along lateral root surface of fractured tooth (Fig. 2), in 4 clinical cases (13.3±6.2%) the bone resorption was observed in the area of bi- and trifurcation of

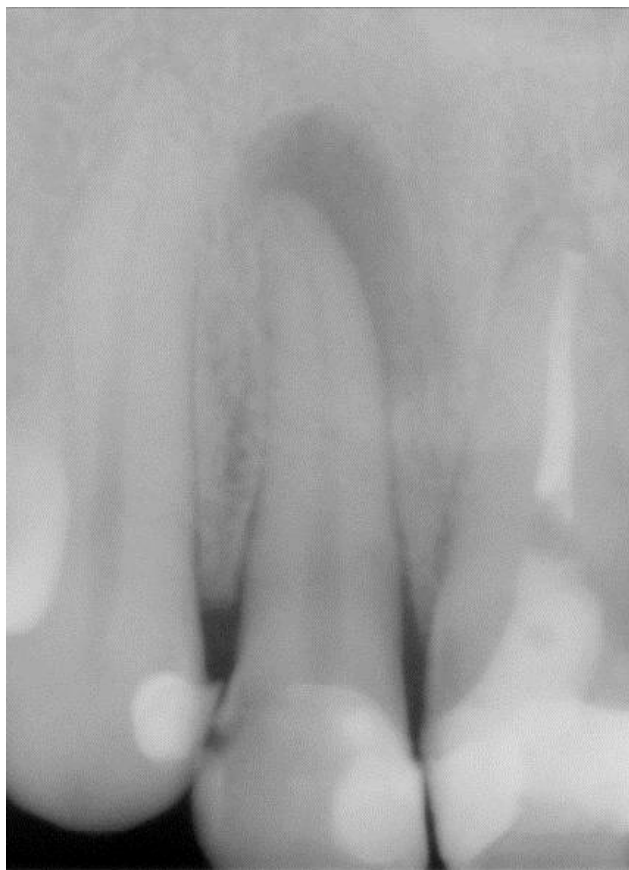
**Fig. 3.** Vertical root fracture of 1.2 tooth with the existing destruction of a "pear / hanging drop" shape.

molar roots; in 2 cases (6.7±4.56%) the periapical lesions were found in the shape of "hanging drop" around the apex. It is known that if a long time passes from the moment of the vertical root fracture, the area of destruction resembles the shape of a "pear / hanging drop" (Fig. 3). Involvement in the pathological process of the coronal part of the root leads to the bone loss similar to periodontal disease with its typical radiological signs (Fig. 4).

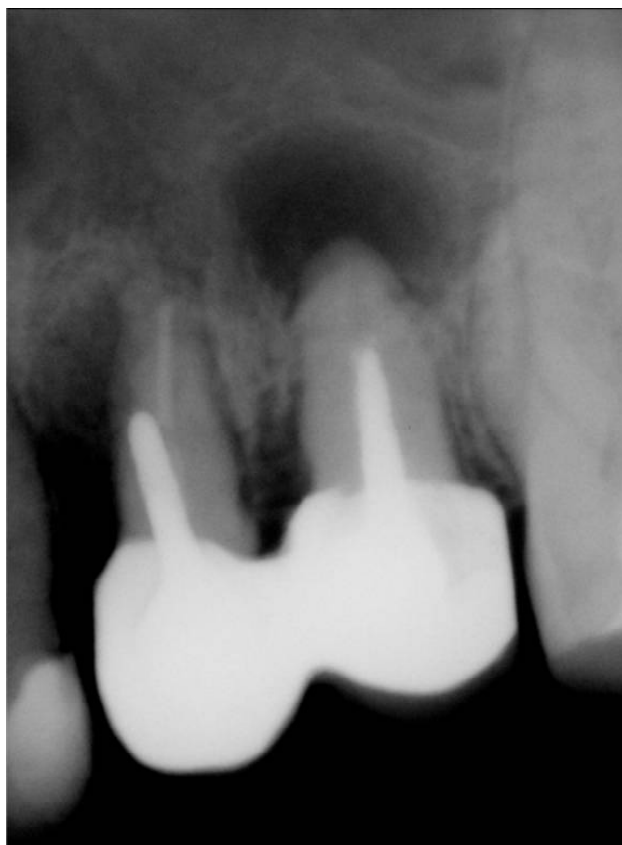
**Fig. 4.** Bone loss in root fracture of 1.4 tooth is similar to periodontal disease.
